Manhole Inspection Summary

Manhole # S31YY1018MH

Insp Date: **1/17/07 9:48 AM**

Location Address: **5212 SAINT ALBANS WAY**

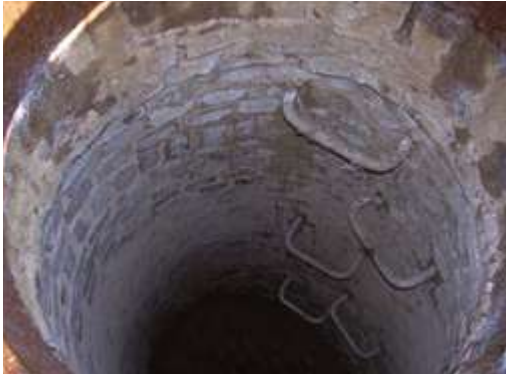
Defect

Frame leaks. Adjustment deterioration and infiltration. Barrel infiltration - other side.

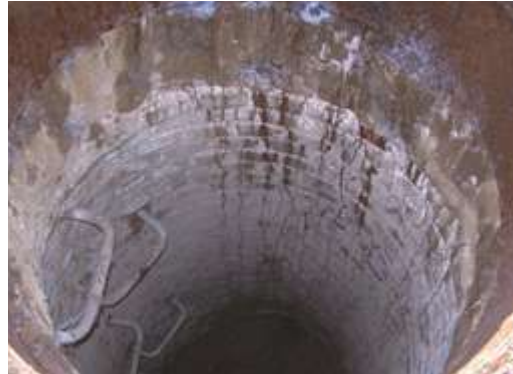
Defect

Frame leaks. Adjustment deterioration and infiltration. Barrel infiltration.

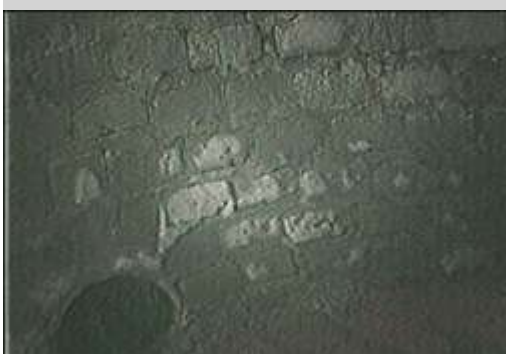
Defect

Barrel deterioration and infiltration.

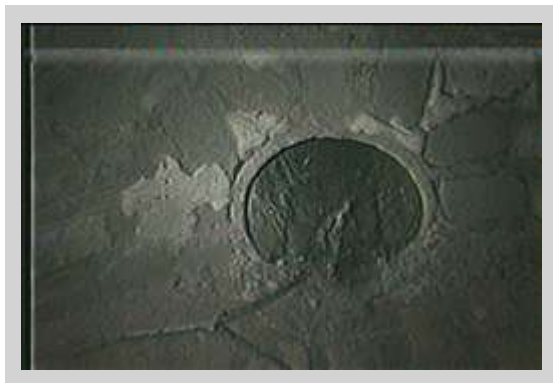
Pipe Out @ 12 O'Clock

Barrel infiltration.
